Test Report

DEVICE TESTED: AusProof 11 kV / 15 kV 800 A Coupler

RANGE NUMBERS: 114BKA, 118BKA, 15BU, 15BUMT, 15BUMTE, 15BUFO

Report Number: PL1792 11-15kV Issue 1

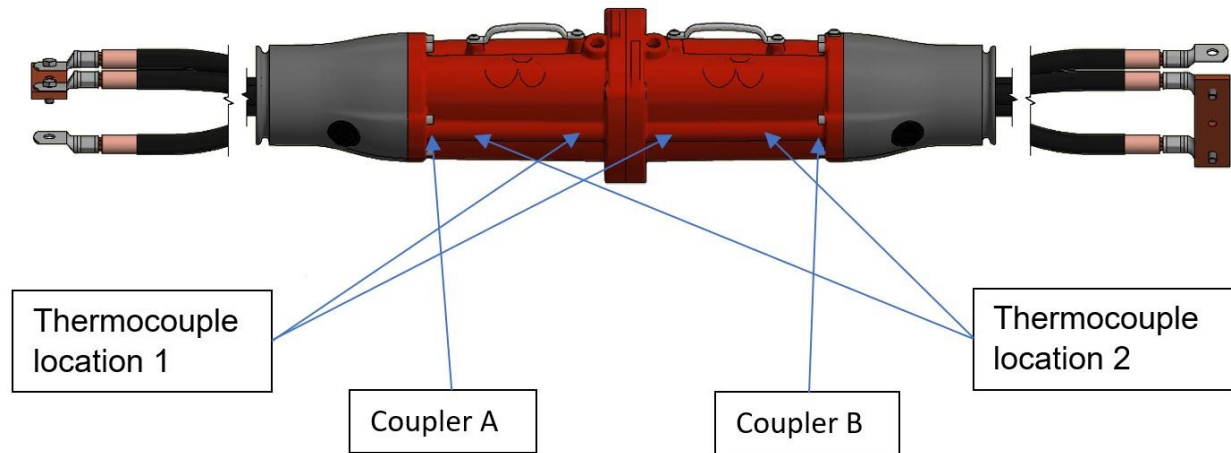
All conductors were connected in series and thermocouples were placed as required by Clause 3.3.8.4 of ASNZS 1300.

Thermocouple locations included:

- (a) Main contact adjacent to connecting device (1)
- (b) Main contact adjacent to cable conductor (2)
- (c) Cable conductor 1 m from cable gland

Location	Coupler	Thermocouple location	Phase ID
A	A	1	White
B	A	2	White
C	A	1	Blue
D	A	2	Blue
E	A	1	Red
F	A	2	Red
G	B	1	Blue
H	B	2	Blue
I	B	1	Red
J	B	2	Red
K	B	1	White
L	B	2	White

A current of 800 A was passed through the test object until the temperature variation did not exceed 2 K/h.

Location	A	B	C	D	E	F	G	H	I	J	K	L
Rise	33.2	30.7	34.0	31.1	30.6	34.7	33.1	30.4	32	32.3	34.4	31.3
Difference from cable	8.4	5.9	9.2	6.3	5.8	9.9	8.3	5.6	7.2	7.5	9.6	6.5

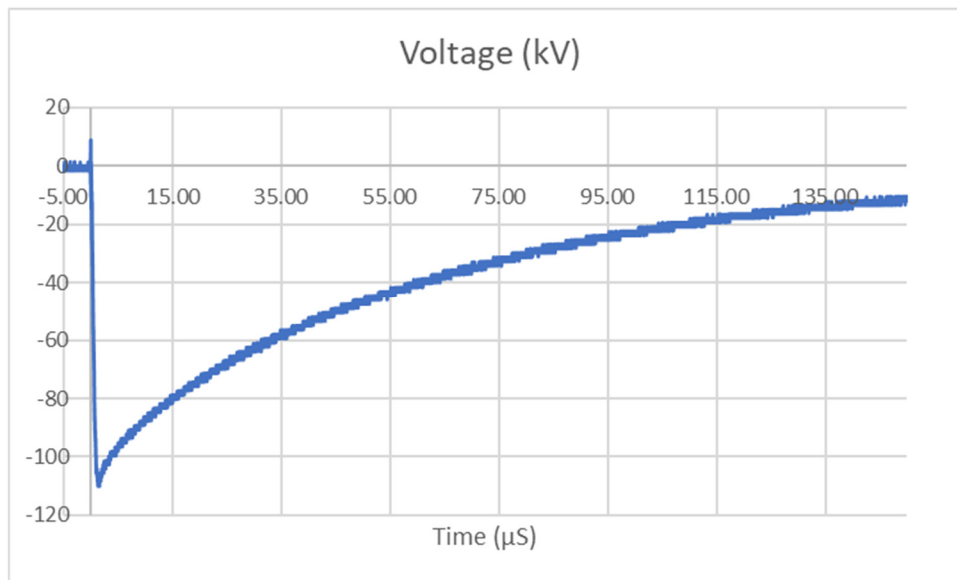
Figure 1. Last 110 kV impulse

Wave shape was 1.0/44 μs. Refer to Figure 1.

A Ferranti impulse generator with a Haefley voltage divider and peak voltmeter was used. The wave shape was adjusted by means of interchangeable front and tail resistors to be within the allowed tolerances.

Ten impulses of each polarity were applied as specified in the Standard. Each impulse was monitored by digital comparison with a stored reference.

The applied impulse was monitored using a Tektronix digitising oscilloscope.

The test voltage was 110 kV peak.

During the application the 110 kV impulses no disruptive discharges, flashovers or insulation punctures were noted.

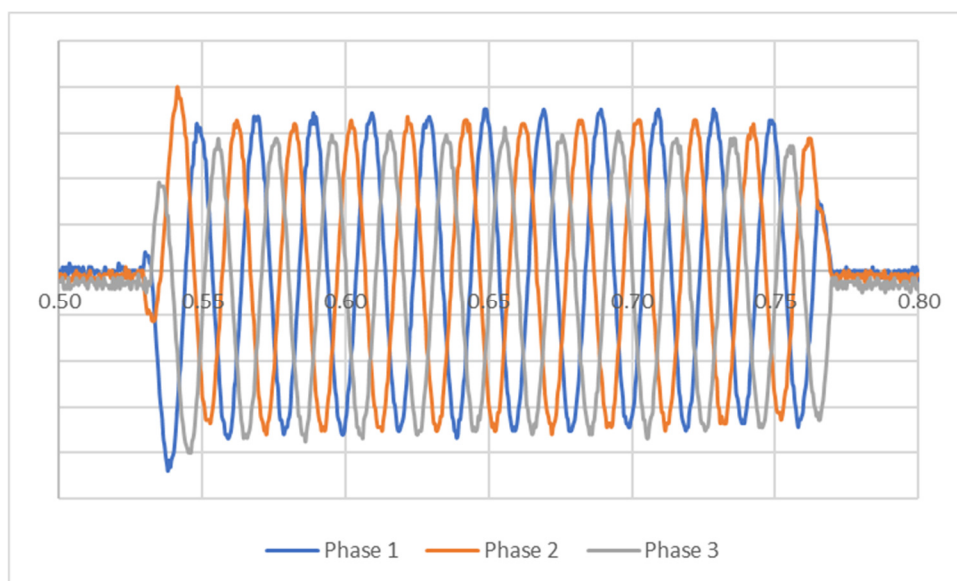
Figure 2. 20 kA for 0.2 s short circuit test number 3

Results: 0.22 s, 20.7 kA, $n=1.9$ (power factor = 0.3), 50 Hz, mean of 3 tests applied with 10 minutes between. Refer to Figure 2.

The device was subjected to the test currents by use of a step down three phase transformer and inductors from an 11 kV supply and a phase controlled on switch and time controlled off circuit breaker:

Test 20 kA 0.2 s

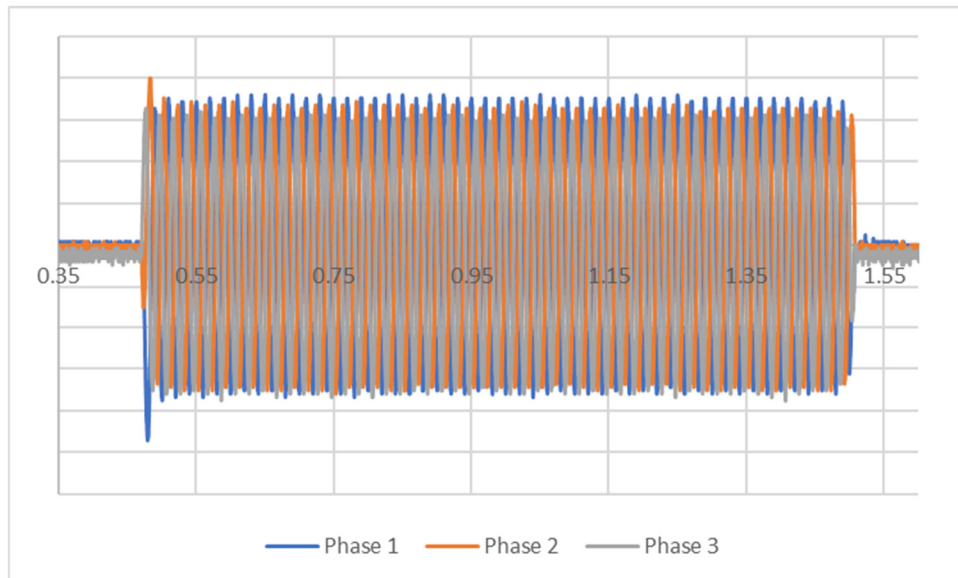
Figure 3. 20 kA for 1 s short circuit test

Results: 1.04 s, 20.8 kA, $n=1.9$ (power factor = 0.3), 50 Hz. Refer to Figure 3.

Test 20 kA 1.0 s

After current applications, there were no visible disturbance, pitting or burning.

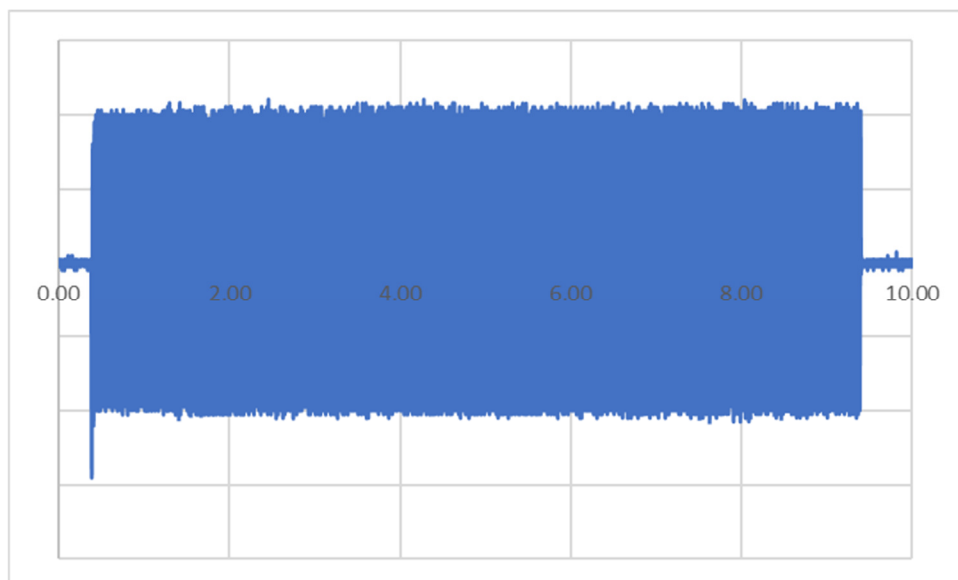
Figure 4. 5 kA for 9 s short circuit test

Results: 9.0 s, 5.1 kA, $n=2.0$, 50 Hz. Refer to Figure 4.

The earth continuity circuit was subjected to the following current waveform by use of a step down transformer and inductors from an 11kV supply and a phase controlled on switch and time controlled off circuit breaker:

Test 5.01 kA for 9 s

The earth continuity was measured on test completion.

After the current application the measured continuity was 0.0001 Ω .
