Test Report

DATE ISSUED:	15 December 2022
DEVICE TESTED:	AusProof 22 kV 425 A Coupler
RANGE NUMBERS:	224BKA, 224BKAFO, 224BKAE, 224BSTDKA, 224B2PKA, 224BSTDKAFO, 224BSTDKAE
CLIENT'S NAME:	AusProof Pty Ltd 6 Shona Avenue Gladstone Queensland 4680 Australia
CLIENT'S REFERENCE:	Email: Clinton Taylor
TEST SPECIFICATION:	Client specification including references to AS/NZS 1300, AS/NZS 1299, C22.2 No 298
DATE OF TEST COMPLETION:	22 November 2022
SUMMARY OF RESULTS:	The sample device tested complied with the requirements of the above test specification.

Report Number: PL1792 22 kV Issue 2

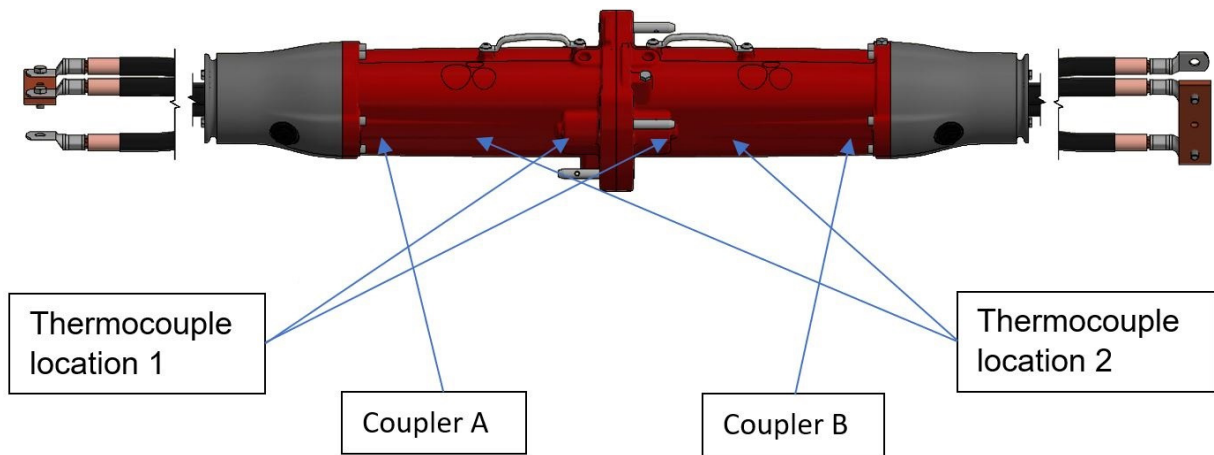
All conductors were connected in series and thermocouples were placed as required by Clause 3.3.8.4 of AS/NZS 1300.

Thermocouple locations included:

- (a) Main contact adjacent to connecting device (1)
- (b) Main contact adjacent to cable conductor (2)
- (c) Cable conductor 1 m from cable gland

Location	Coupler	Thermocouple location	Phase ID
A	A	1	White
B	A	2	White
C	A	1	Blue
D	A	2	Blue
E	A	1	Red
F	A	2	Red
G	B	1	Blue
H	B	2	Blue
I	B	1	Red
J	B	2	Red
K	B	1	White
L	B	2	White

A current of 425 A was passed through the test object until the temperature variation did not exceed 2 K/h.

Location	A	B	C	D	E	F	G	H	I	J	K	L
Rise	25	25	29	26	25	25	29	17	28	25	29	26
Difference from cable	-13	-13	-9	-12	-13	-13	-9	-21	-10	-13	-9	-12

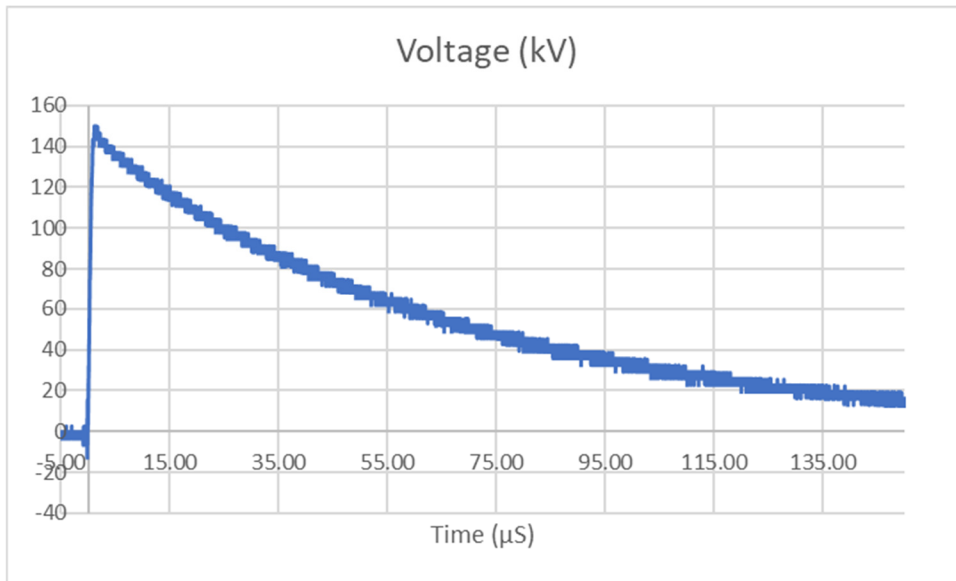
Figure 1. Last 150 kV impulse

Wave shape was 1.0/44 μ s. Refer to Figure 1

Refer to Figure 1.

A Ferranti impulse generator with a Haefley voltage divider and peak voltmeter was used. The wave shape was adjusted by means of interchangeable front and tail resistors to be within the allowed tolerances.

Ten impulses of each polarity were applied as specified in the Standard. Each impulse was monitored by digital comparison with a stored reference.

The applied impulse was monitored using a Tektronix digitising oscilloscope.

The test voltage was 125 kV peak.

The test was then repeated with a test voltage of 150 kV peak

During the application the 150 kV impulses no disruptive discharges, flashovers or insulation punctures were noted.

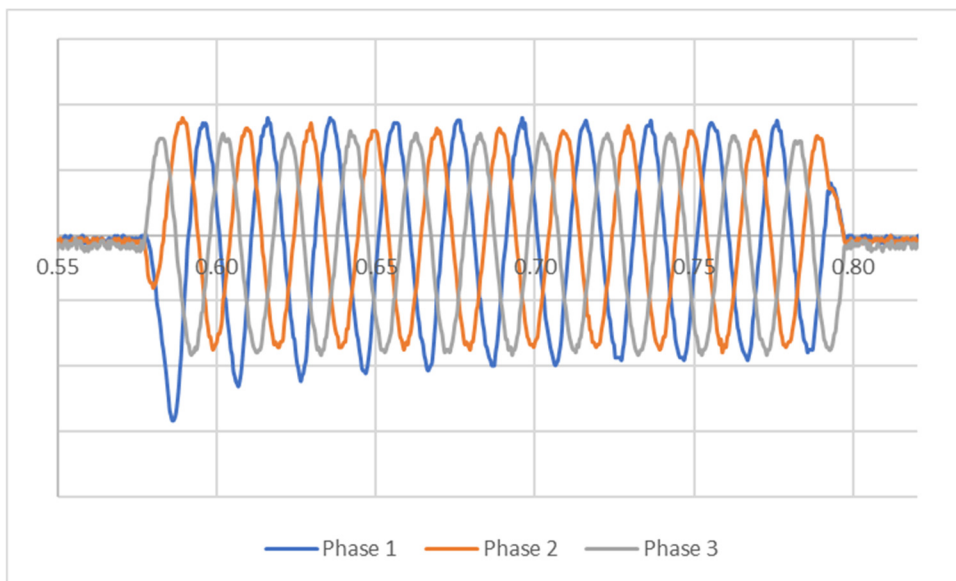
Figure 2. 20 kA for 0.2 s short circuit test number 3

Results: 0.22 s, 21.4 kA, n=2.0 (power factor = 0.3), 50 Hz, mean of 3 tests applied with 10 minutes between. Refer to Figure 2.

The device was subjected to the test currents by use of a step down three phase transformer and inductors from an 11 kV supply and a phase controlled on switch and time controlled off circuit breaker:

Test 20 kA 0.2 s

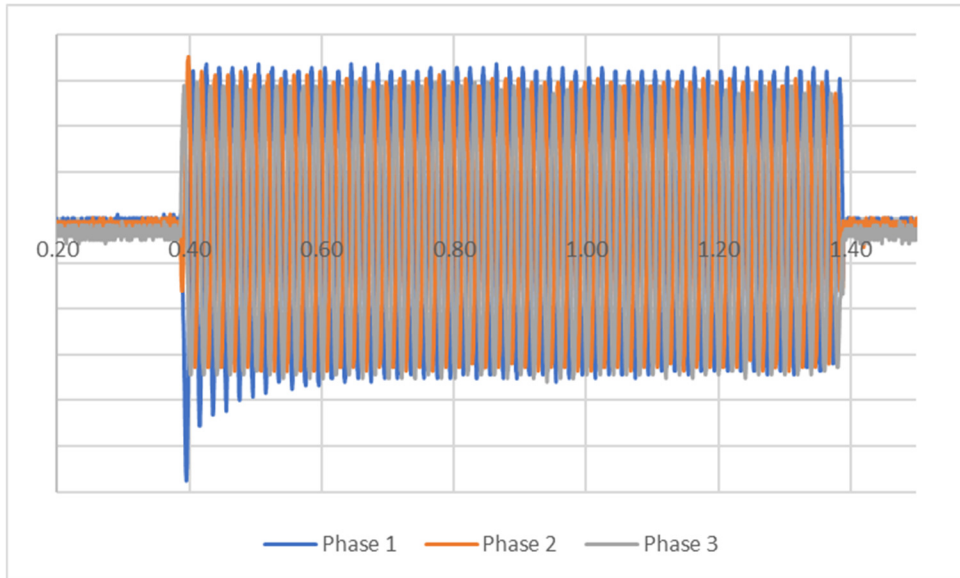
Figure 3. 20 kA for 1 s short circuit test

Results: 1.02 s, 19.7 kA, n=2.5 (power factor = 0.3), 50 Hz. Refer to Figure 3.

Test 20 kA 1.0 s

After current applications, there were no visible disturbance, pitting or burning.

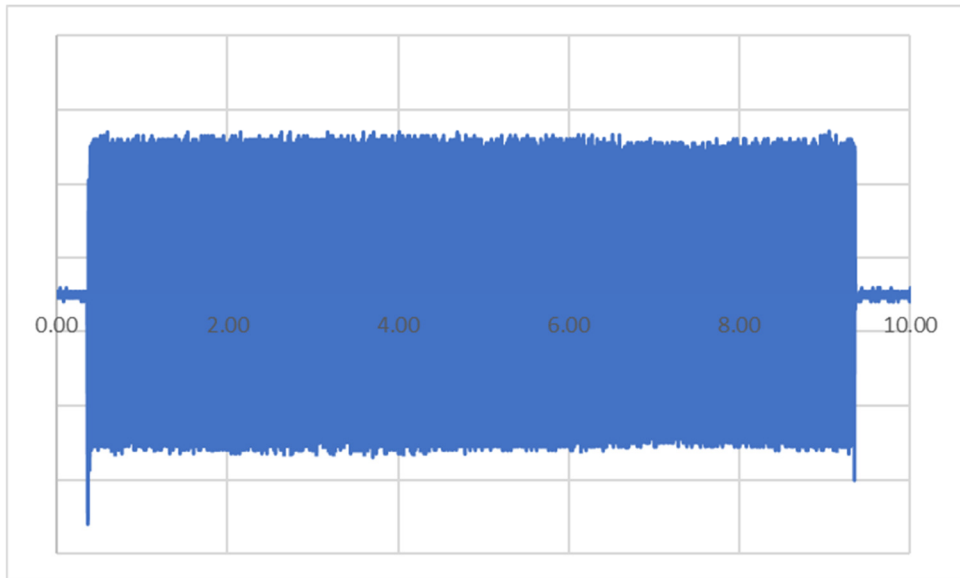
Figure 4. 5 kA for 9 s short circuit test

Results: 9.04 s, 5.1 kA, n=2.1, 50 Hz. Refer to Figure 4.

The earth continuity circuit was subjected to the following current waveform by use of a step down transformer and inductors from an 11kV supply and a phase controlled on switch and time controlled off circuit breaker:

Test 5.01 kA for 9 s

After the current application the measured continuity was 0.0001 Ω .

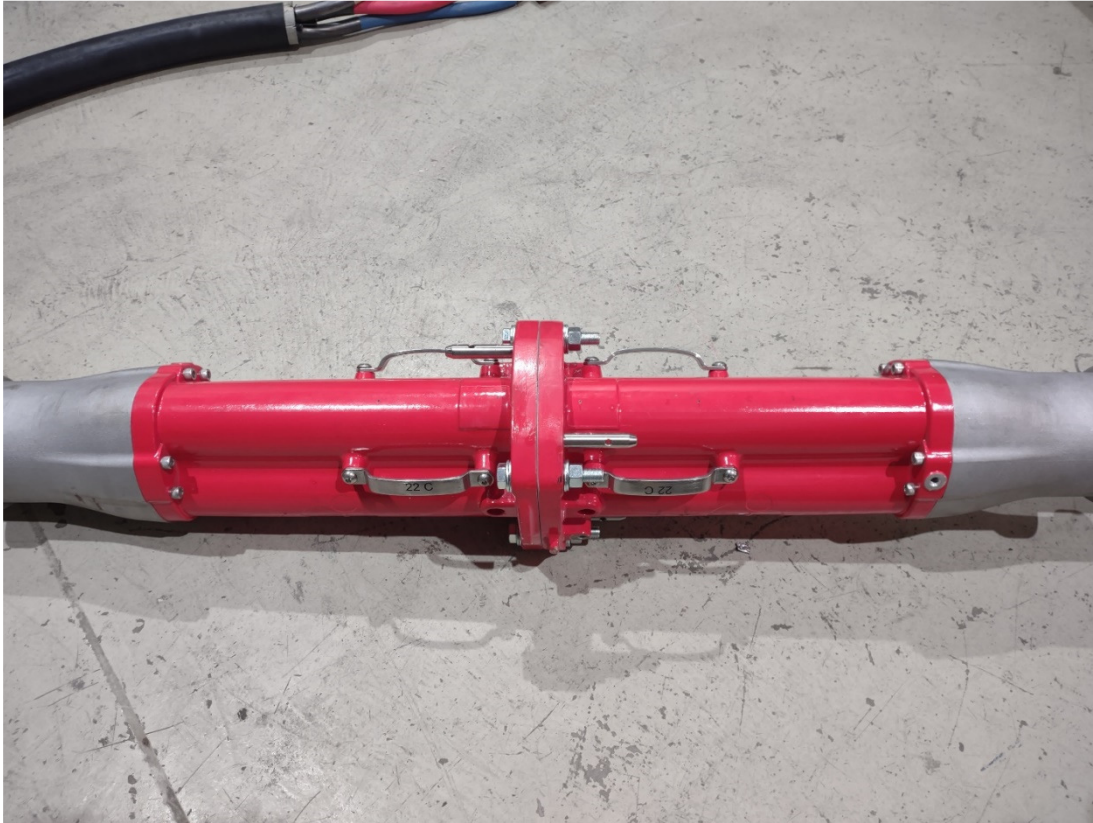
Picture 1 General view of coupler

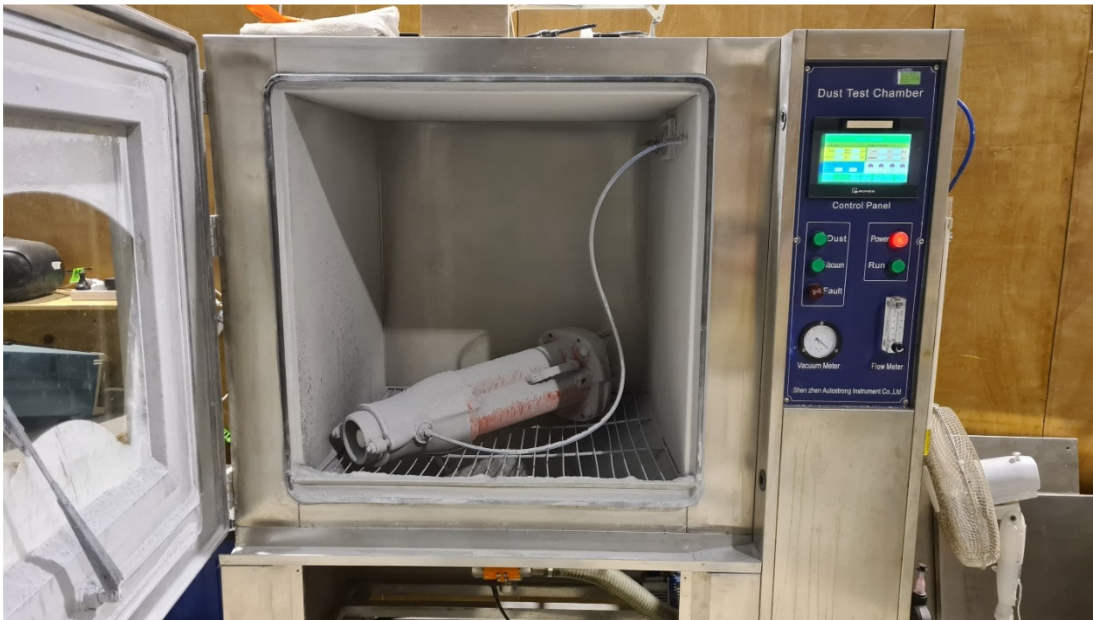
Picture 2 Coupler in dust test

CI 13.6	Ingress of Dust Test (AS 60529)				P
EUT identification	Degree of protection (Dust)	Duration of test (hr)	Ambient temperature (°C)	EUT ambient (°C)	Verdict

Unit 3	IP6X	6.8	15.4	20.1	P
Unit 4	IP6X	6.8	15.1	20.5	P

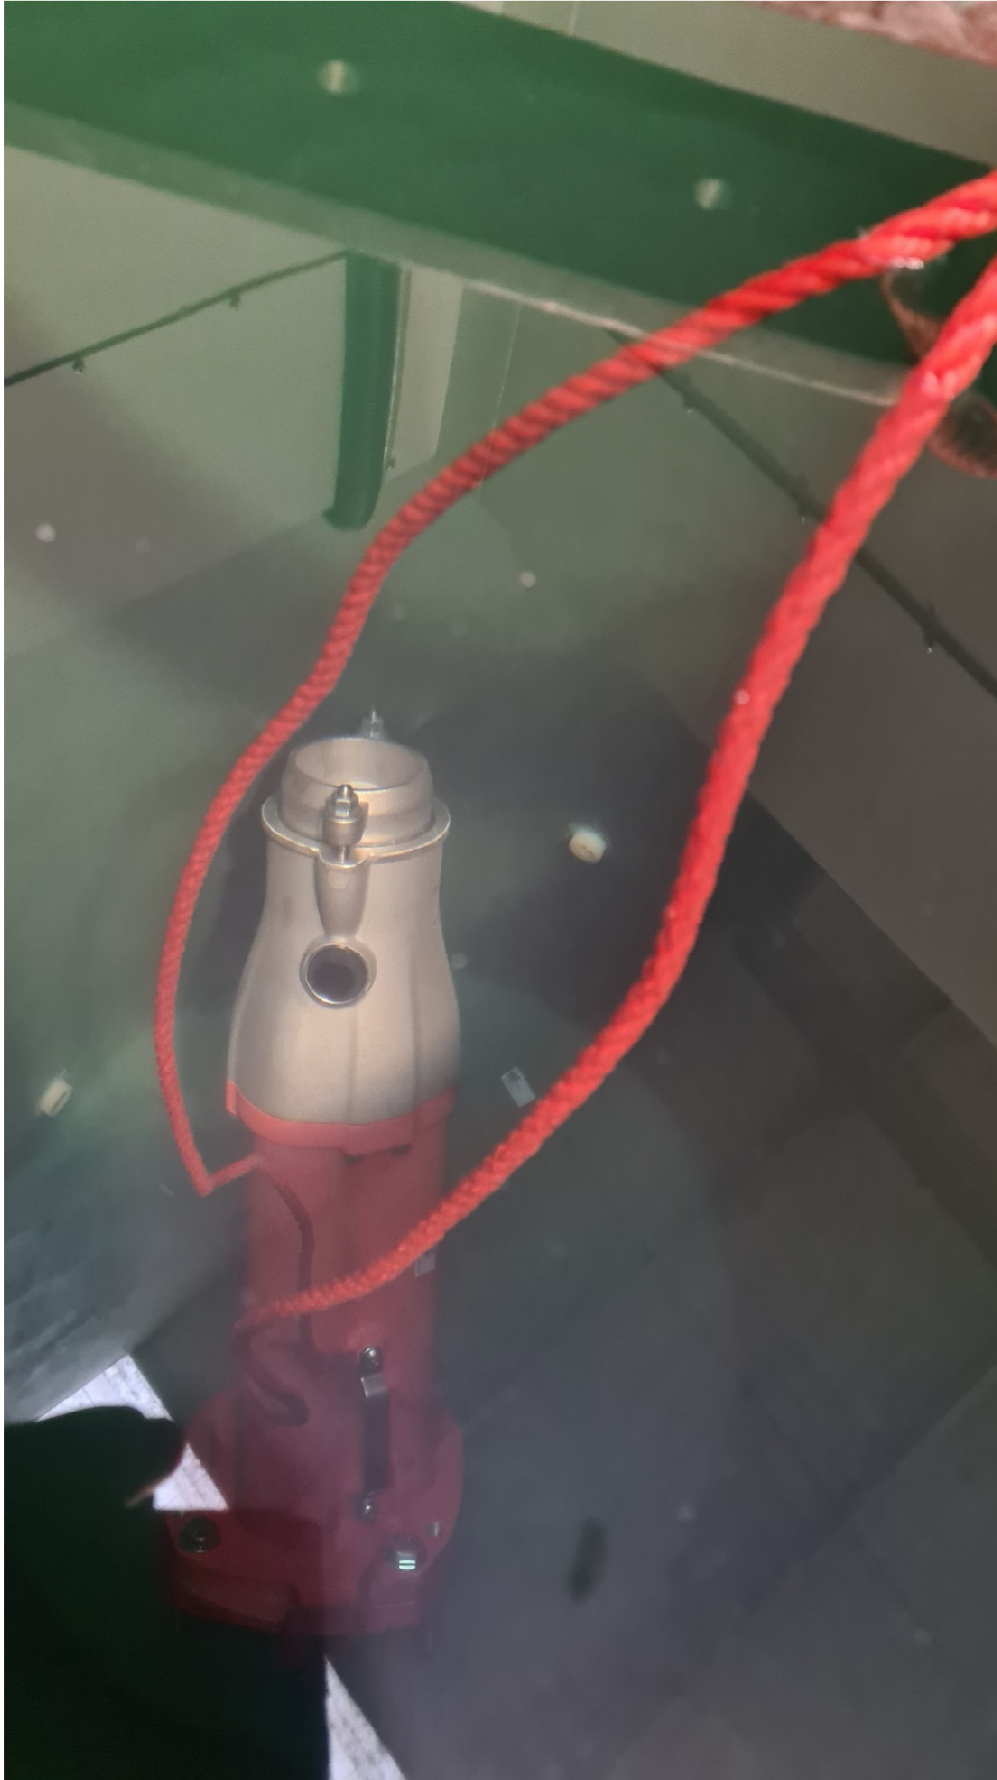
Picture 3 Coupler in 1 m water

CI 14.3	Ingress of Water Test (AS 60529)					P
EUT identification	Degree of protection (Water)	Depth of EUT from surface (m)	Duration of test (min)	Ambient temperature (°C)	Water Ambient temperature (°C)	Verdict
Unit 3	IPX8	1.1	60.0	15.2	17.0	P
Unit 4	IPX8	1.1	60.0	15.4	17.2	P

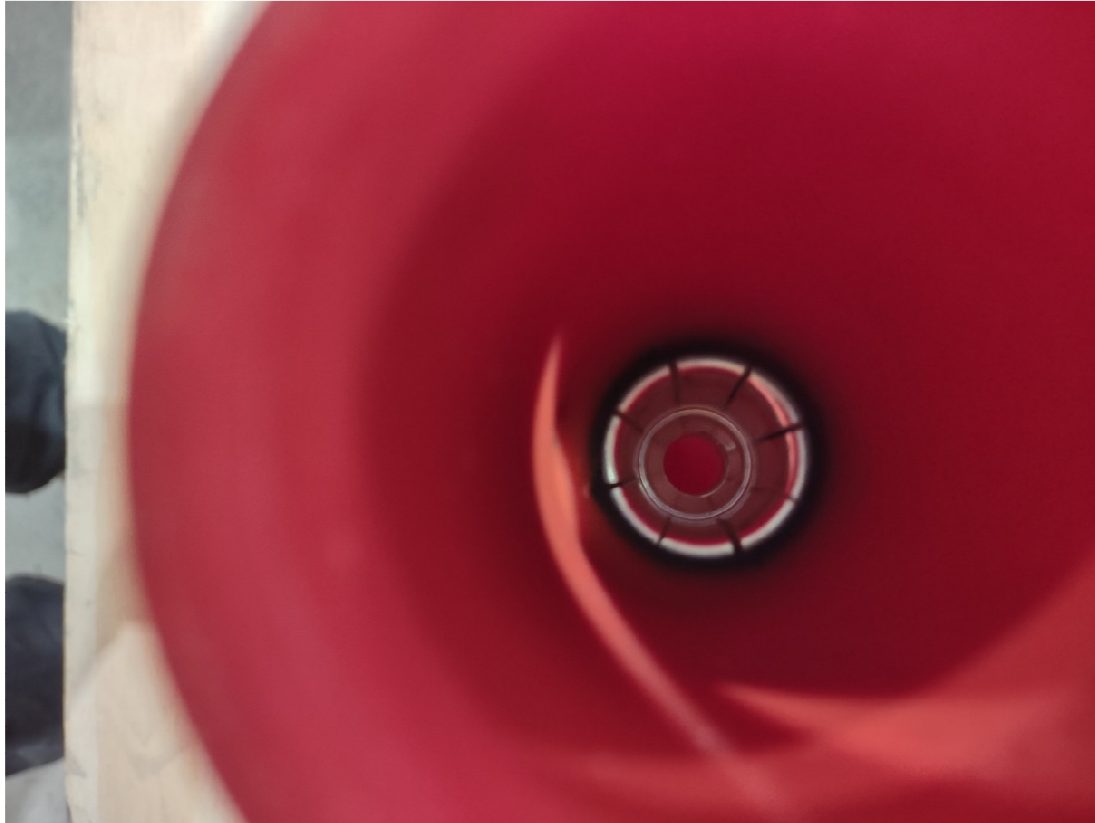
Picture 4 Contacts after short circuit test

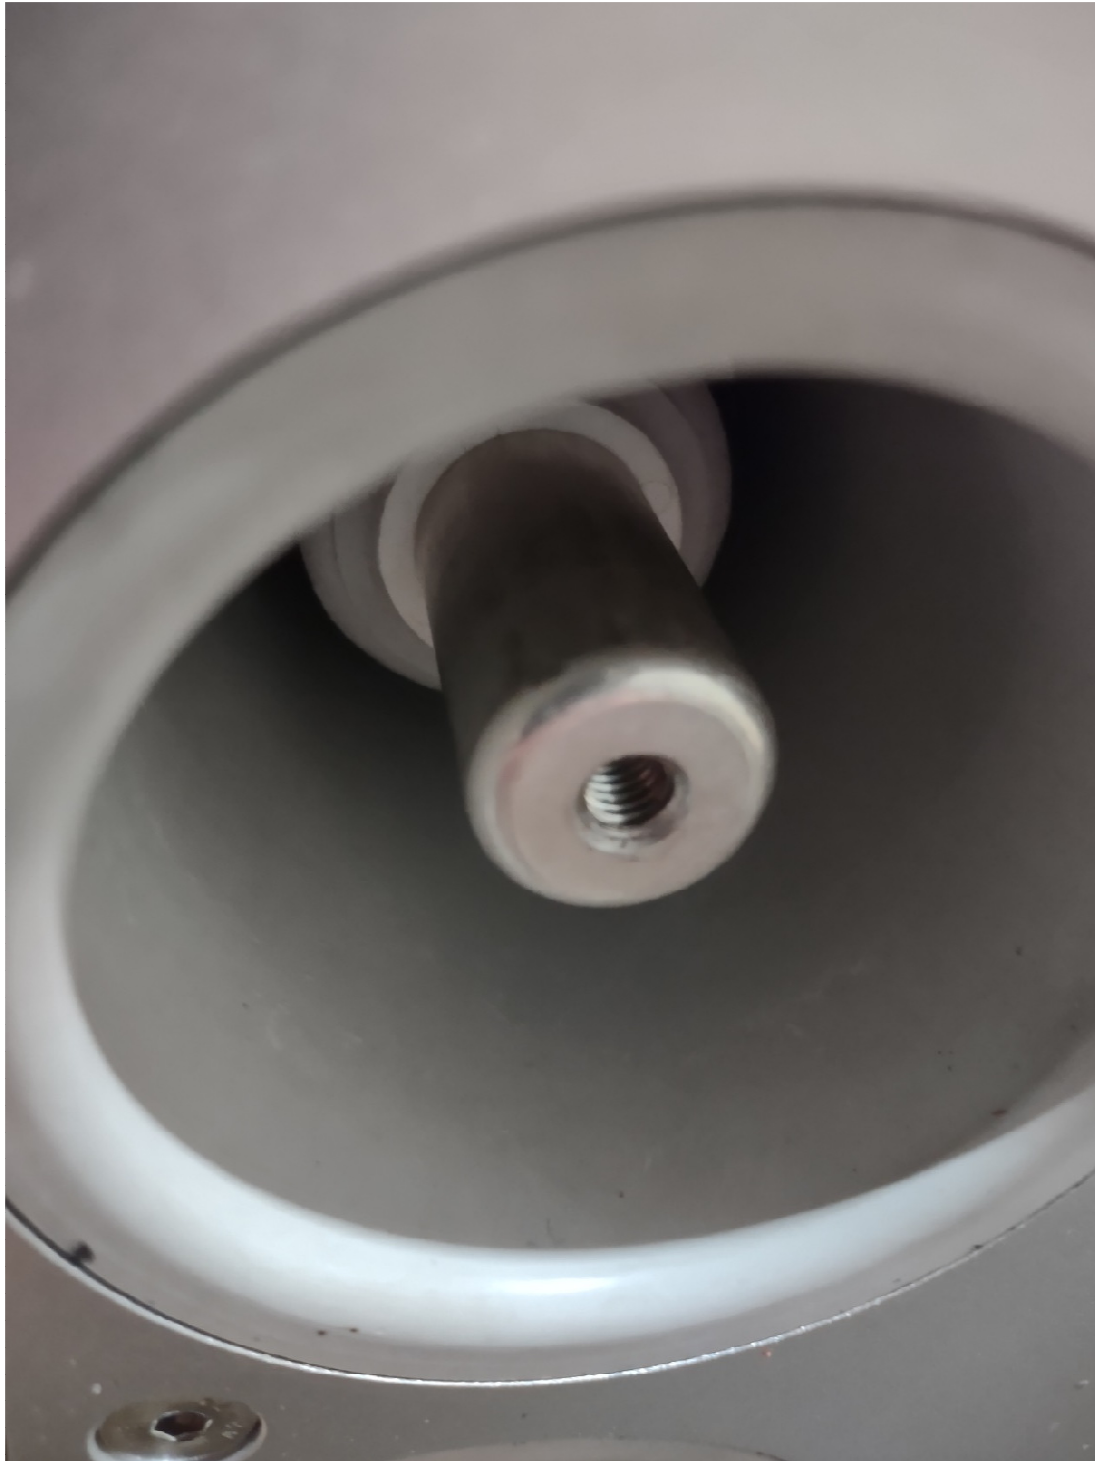
Picture 5 Contacts after short circuit test
