# **Test Report**

**DEVICE TESTED**: AusProof 25 kV 800 A Coupler

**TEST SPECIFICATION**: Client specification including references to

**DATE OF TEST COMPLETION**: 22 November 2022

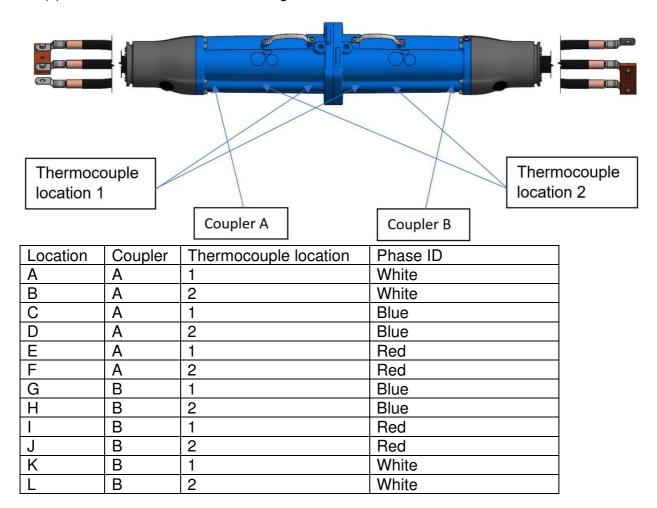
All conductors were connected in series and thermocouples were placed as required by Clause 3.3.8.4 of ASNZS 1300.

Thermocouple locations included:

- (a) Main contact adjacent to connecting device (1)
- (b) Main contact adjacent to cable conductor (2)
- (c) Cable conductor 1 m from cable gland

Location	Α	В	С	D	Е	F	G	Н		J	K	L
Rise	34	39	40	36	34	38	41	40	37	38	38	35
Difference from cable	-2	3	4	0	-2	2	5	4	1	2	2	-1

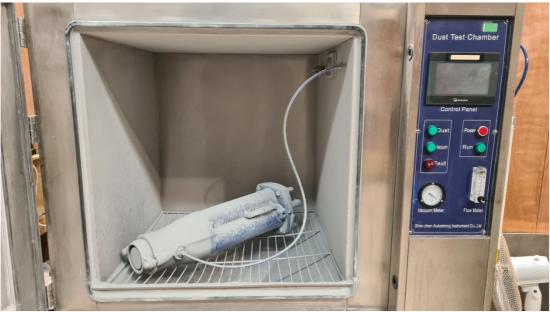
Picture 2 Coupler in dust test

CI 13.6	Ingre	Ingress of Dust Test (AS 60529)							
EUT identification		Degree of protection (Dust)	Duration of test (hr)	Ambient temperature (°C)	EUT ambient (°C)	Verdict			
Unit 1		IP6X	6.1	15.1	24.4	Р			
Unit 2		IP6X	6.1	15.0	20.9	Р

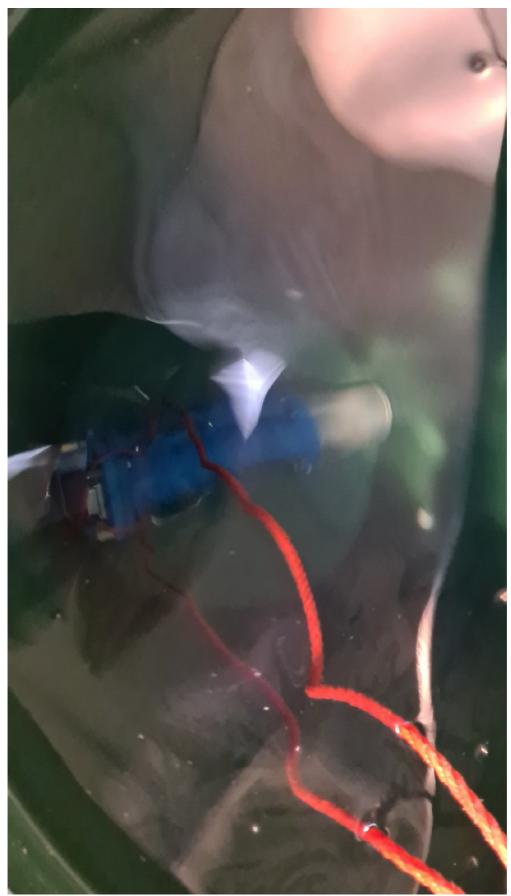
Picture 3 Coupler in 1 m water

CI 14.3	Ingre	Ingress of Water Test (AS 60529)								
EUT identification		Degree of protection (Water)	Depth of EUT from surface (m)	Duration of test (min)	Ambient temperature (°C)	Water Ambient temperature (°C)	Verdict			
Unit 1		IPX8	1.1	60.0	15.0	17.4	Р			
Unit 2		IPX8	1.1	60.0	15.4	16.4	Р

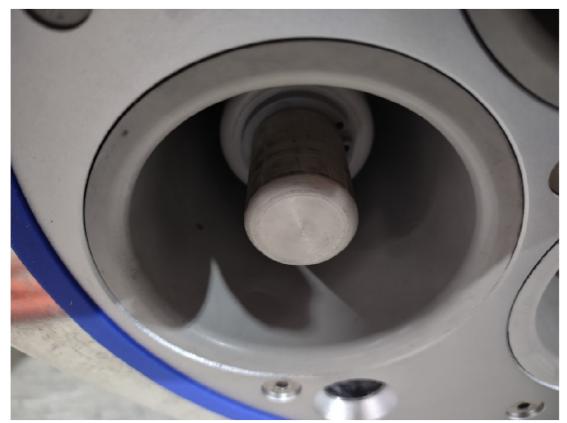
Picture 4 Contacts after short circuit test

After current applications, there were no visible disturbance, pitting or burning.

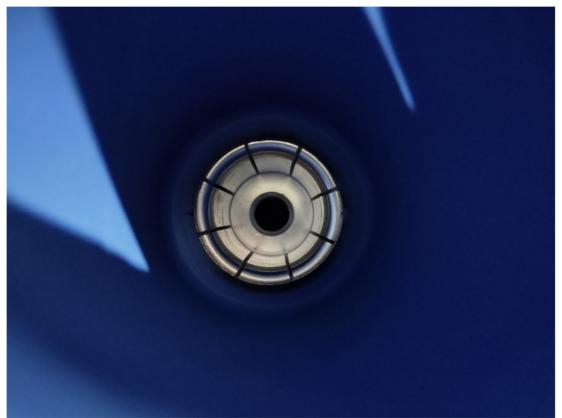
Picture 5 Contacts after short circuit test
