Test Report

DEVICE TESTED: AusProof 6.6 kV / 8.7 kV 800 A Coupler

TEST SPECIFICATION: Client specification including references to

AS/NZS 1300, AS/NZS 1299, C22.2 No 298, AS/NZS 1802, AS/NZS 2802 and IEEE 404

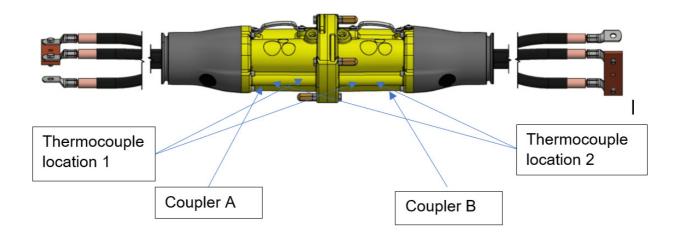
All conductors were connected in series and thermocouples were placed as required by Clause 3.3.8.4 of ASNZS 1300.

Thermocouple locations included:

- (a) Main contact adjacent to connecting device (1)
- (b) Main contact adjacent to cable conductor (2)
- (c) Cable conductor 1 m from cable gland

Location	Coupler	Thermocouple location	Phase ID
Α	Α	1	White
В	Α	2	White
С	Α	1	Blue
D	Α	2	Blue
Е	Α	1	Red
F	Α	2	Red
G	В	1	Blue
Н	В	2	Blue
1	В	1	Red
J	В	2	Red
K	В	1	White
L	В	2	White

Location	Α	В	С	D	Е	F	G	Н	I	J	K	L
Rise	40	38	40	36	37	39	37	38	37	37	42	39
Difference from cable	9	7	8	5	5	8	6	7	6	5	10	8

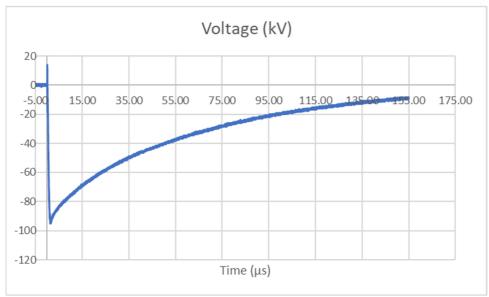
Figure 1. Last 95 kV impulse

Wave shape was 1.0/43 µs. Refer to oscillogram included in this report

The test voltage was 75 kV peak.

The test was then repeated with a test voltage of 95 kV peak

During the application the 95 kV impulses no disruptive discharges, flashovers or insulation punctures were noted. Refer to Figure 1.

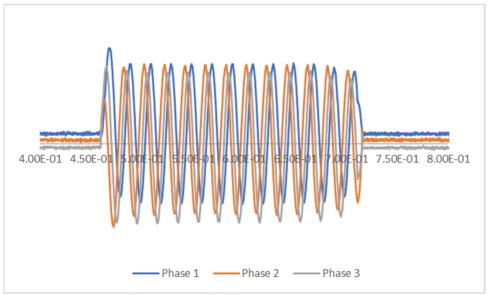
Figure 2. 20 kA for 0.2 s short circuit test number 3

Test 20 kA 0.2 s

Results: 0.22 s, 21.8 kA, n=2.0 (power factor = 0.3), 50 Hz, mean of 3 tests applied with 10 minutes between. Refer to Figure 2.

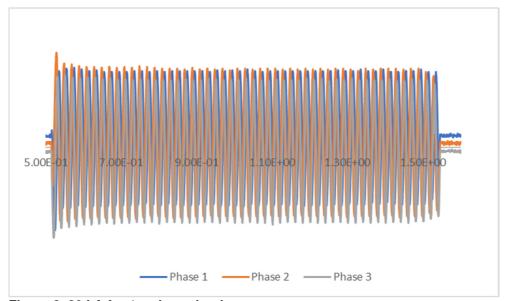
Figure 3. 20 kA for 1 s short circuit test

Test 20 kA 1.0 s

Results: 1.03 s, 20.8 kA, n=2.0 (power factor = 0.3), 50 Hz. Refer to Figure 3.

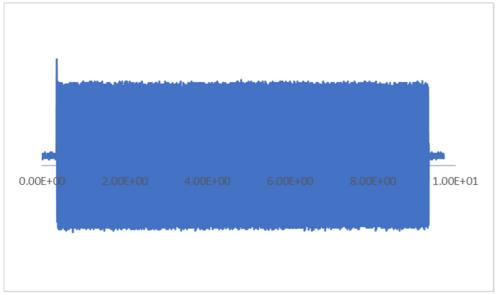
Figure 4. 5 kA for 9 s short circuit test

Test 5.01 kA for 9 s

Results: 9.3 s, 5.0 kA, n=1.9, 50 Hz. Refer to Figure 4.

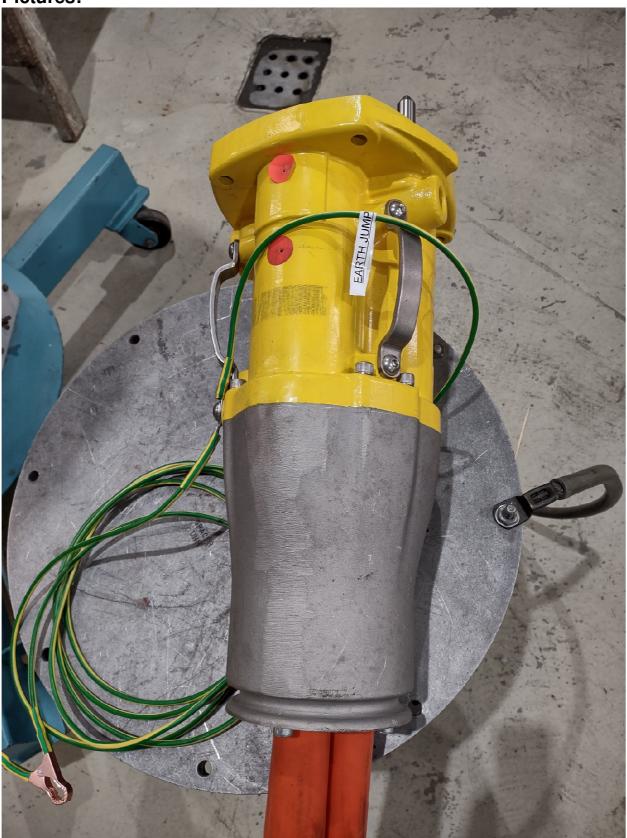
Picture 1 General view of coupler

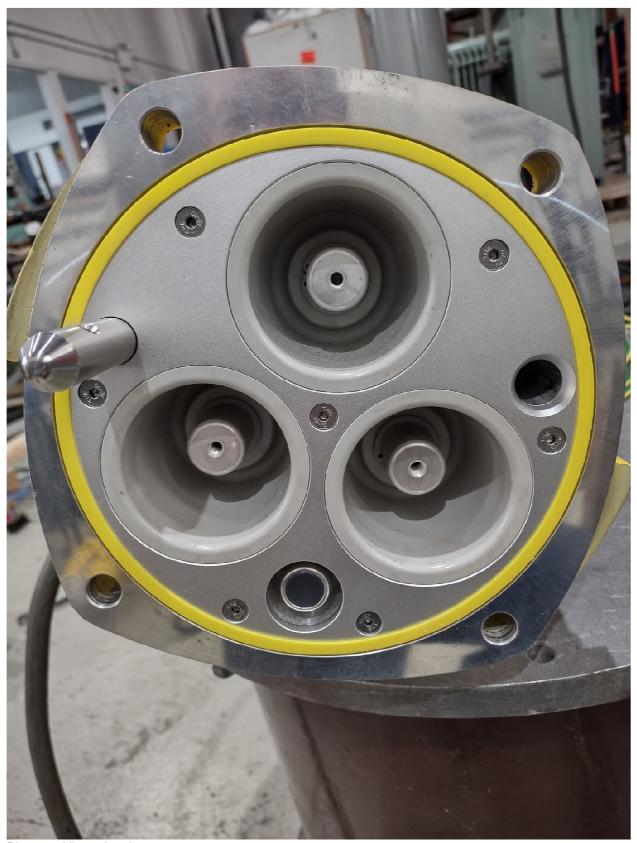
Picture 2 View of main contacts

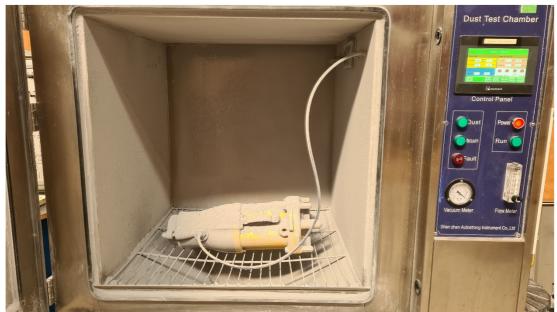
Picture 3 Coupler in dust test

CI 13.6	Ingre	Ingress of Dust Test (AS 60529)							
EUT identification	n	Degree of protection (Dust)	Duration of test (hr)	Ambient temperature (°C)	EUT ambient (°C)	Verdict			
Unit 1		IP6X	2.6	24.6	31.9	Р			
Unit 2		IP6X	2.6	22.6	29.6	Р

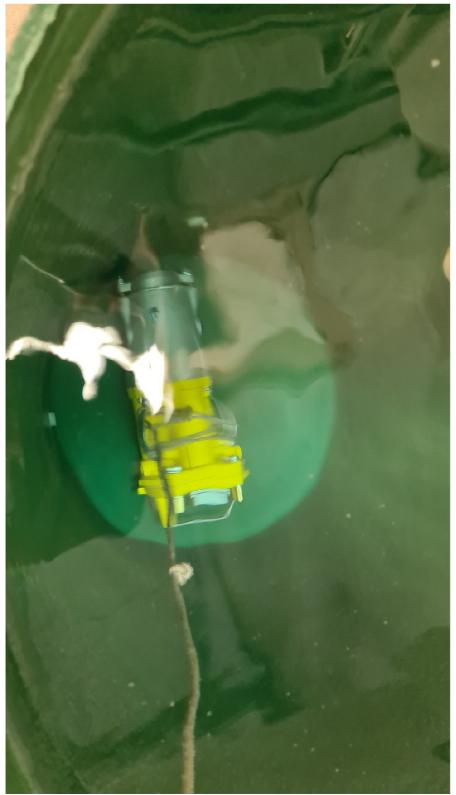
Picture 4 Coupler in 1 m water

CI 14.3	Ingre	Ingress of Water Test (AS 60529)							
EUT identification	า	Degree of protection (Water)	Depth of EUT from surface (m)	Duration of test (min)	Ambient temperature (°C)	Water Ambient temperature (°C)	Verdict		
Unit 1		IPX8	1.0	60.0	23.8	22.2	Р		
Unit 2		IPX8	1.0	60.0	23.0	22.8	Р

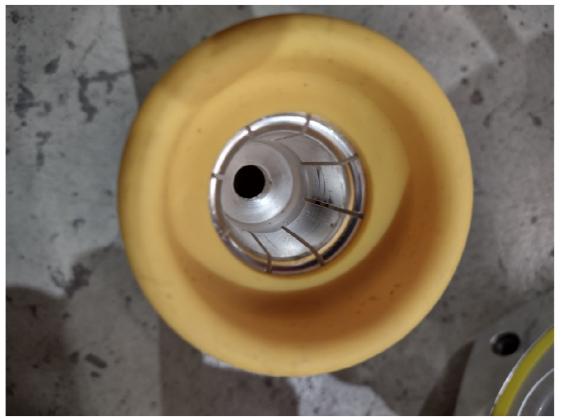
Picture 5 Contacts after short circuit test

After current applications, there were no visible disturbance, pitting or burning.

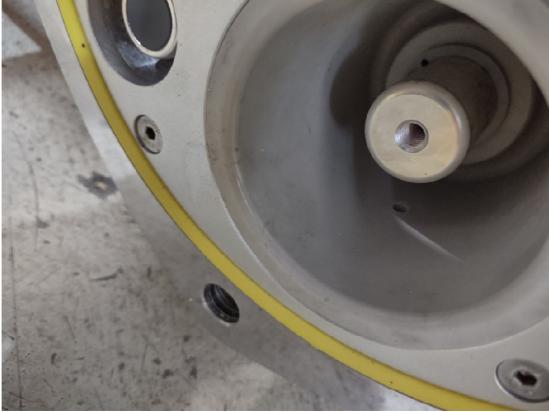
Picture 6 Contacts after short circuit test
